A TECHNICAL SUMMARY OF PERFORMANCE:
APPLYING VIROPHOS MEDIA IN A NOVEL WET POND
LITTORAL SHELF FILTER RETROFIT

Jeffrey Johnson, Ph.D.
North Carolina State University
Stormwater Engineering Group

6/22/2020

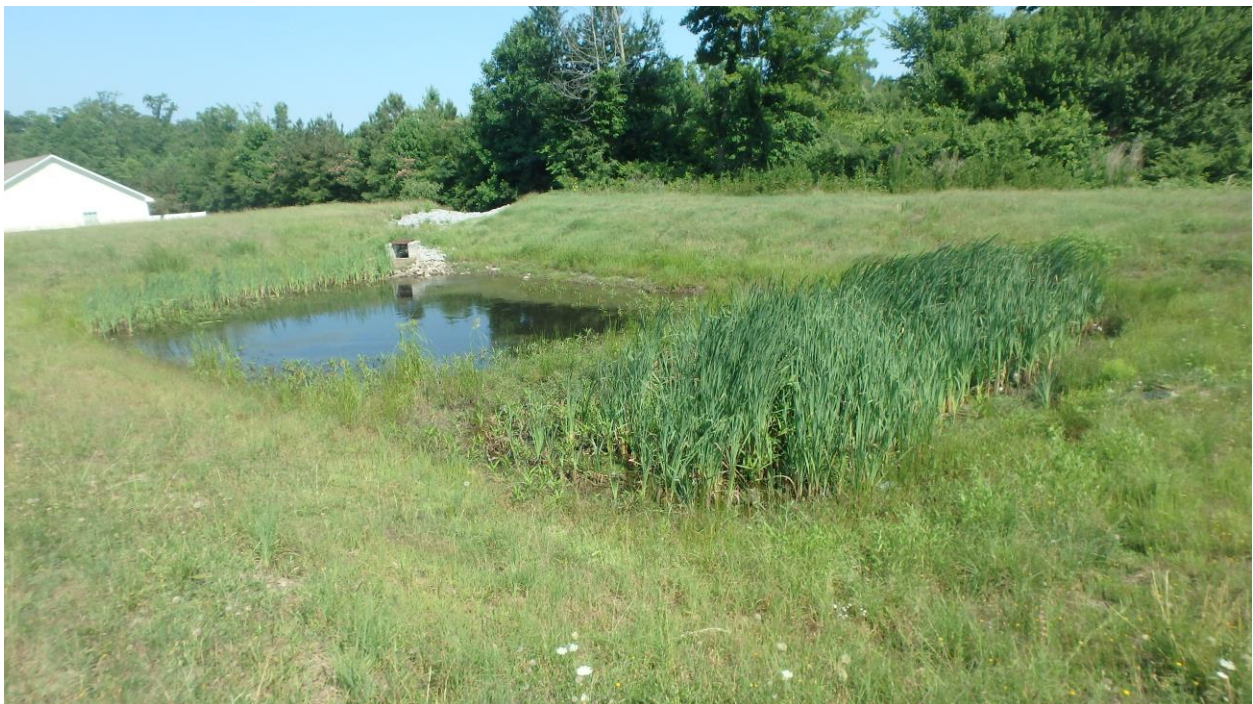
Figure 1. Sapphire wet pond in Rocky Mount, NC.

The 3,600-ft² wet pond receiving runoff from a 7.3-acre residential area watershed was retrofit with a 408-ft² littoral shelf filter in October 2017. The filter was installed along

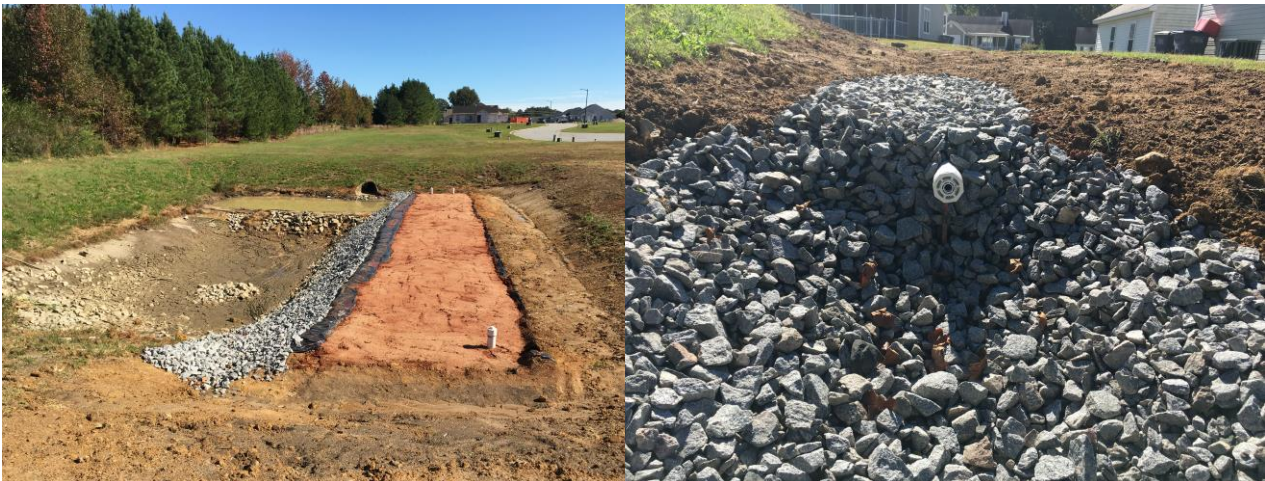
Figure 2. Littoral shelf filter following construction (left) and underdrain (right).

the south bank of the wet pond (Fig. 2). The filter was installed at permanent pool elevation with an approximately 4-inch high berm separating the filter surface from the permanent pool surface. The filter was lined with an impermeable liner to prevent seepage of water from the banks of the pond and ensure only stormwater above the permanent pool would be routed through the system. Above the impermeable liner, the filter was backfilled with a 6-inch layer of double-washed #57 stone, a 3-inch layer of double-washed #87 stone, and 1.5 feet of ViroPhos filter media. The filter was drained through two 4-inch perforated underdrains that were daylighted to a swale outside of the wet pond and fitted to a 1-inch nozzle.

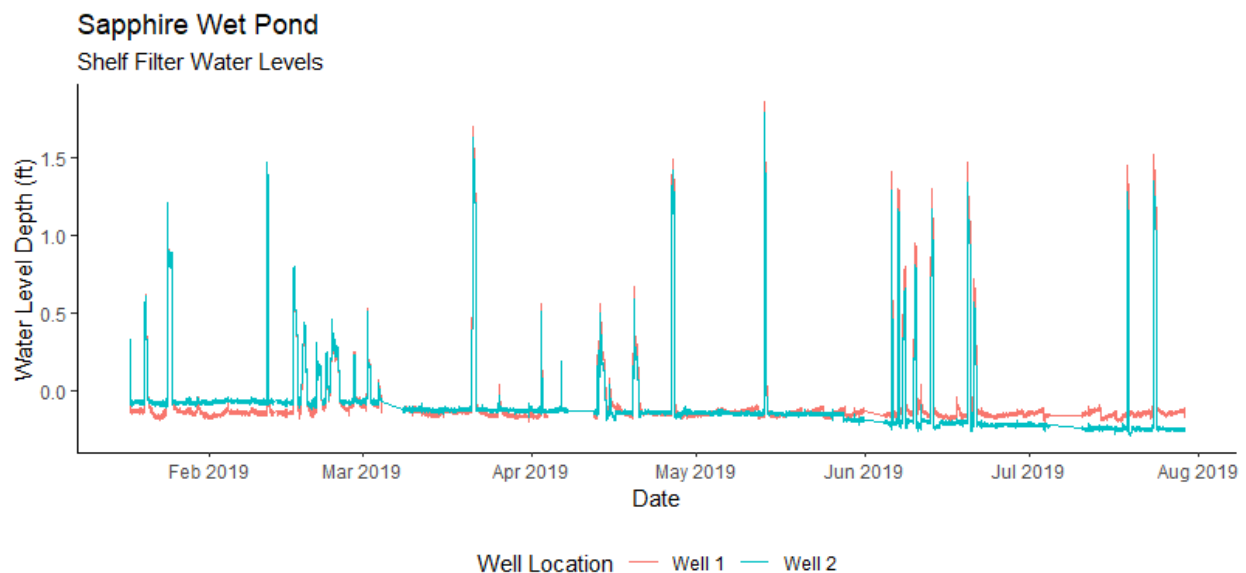
Figure 3. Water levels within the filter from June - December 2018.

Runoff successfully infiltrated the filter for the majority of the monitoring period (Fig. 3). A concern with the installation of littoral shelf filters is the biologically active nature of wet pond ecosystems and its effect on filter blinding and maintenance. Biological blinding was observed on occasion during the growing season; however, infiltration was restored following raking of the filter surface (Fig. 4).

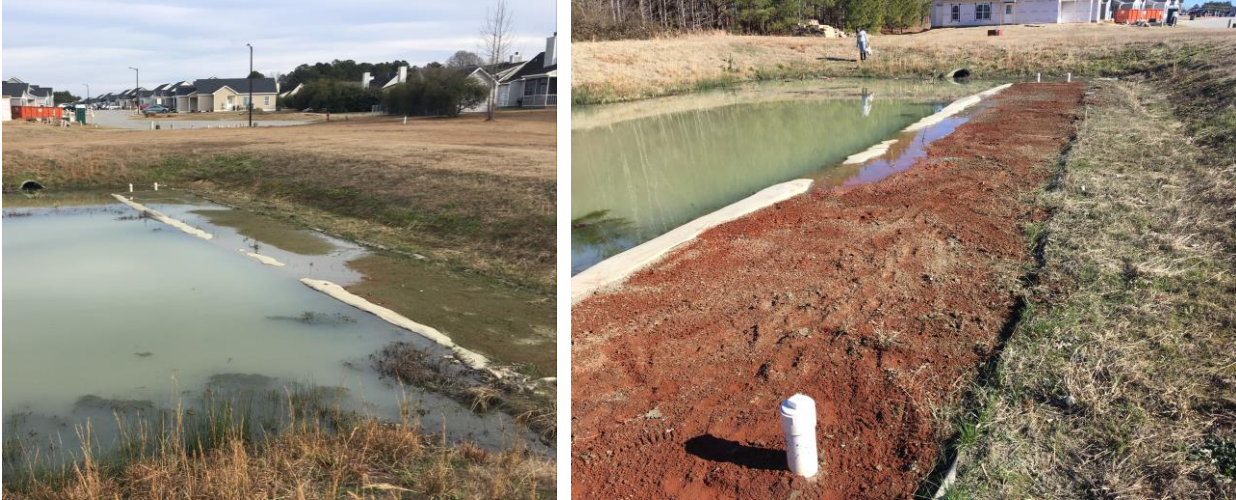
Figure 4. Biological blinding of the shelf filter observed at the Sapphire pond (left) remedied by raking of the filter surface (right).
